SERVICE Information

Title: Hinge Batten Fitting Security

Identification	SB-019
Status	Active
Issue	1
Issue Date	01-09-2015
Applicability	All Airborne Windsports Wings
Compliance	100 Hourly line maintenance
Reference Material	Airborne Engineering Report 15/025/DS

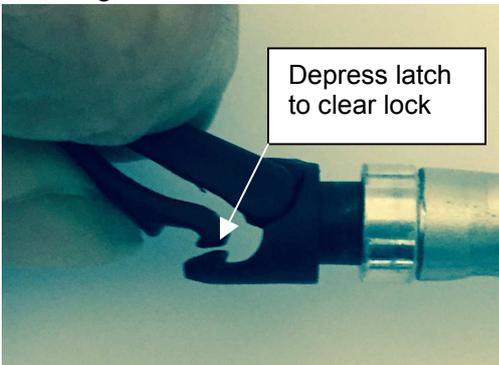
It is important that the locking latch is depressed adequately to clear the capture clasp when unloading.

Testing of fittings that have been unloaded without depressing the locking latch adequately have seen a reduction in latch security.

If the clip is opened by force without properly depressing the latch it can result in a 25% reduction in latch strength. The reduction in strength can be greater and continual improper unloading will see further degradation in strength of the locking mechanism.

Sand and grit on the latch area will also reduce the latch strength. Ensure area is clean.

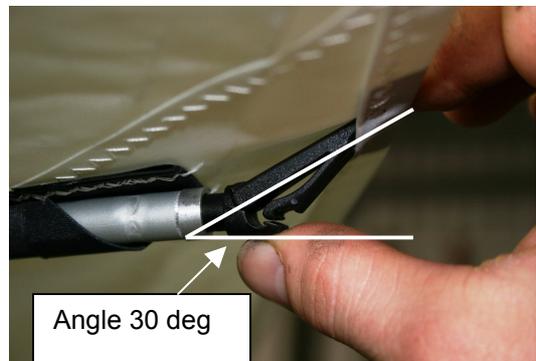
Over tensioning of battens will cause degradation of handling as well as overloading the latch. In particular, a mylar sail tends to shrink as it ages so checking of the batten tension periodically is required.

The correct tension is applied to the batten when loading with minimal pressure applied an angle of 30° is achieved (See diagram).

Airborne Flight manuals show how to correctly tension your battens.

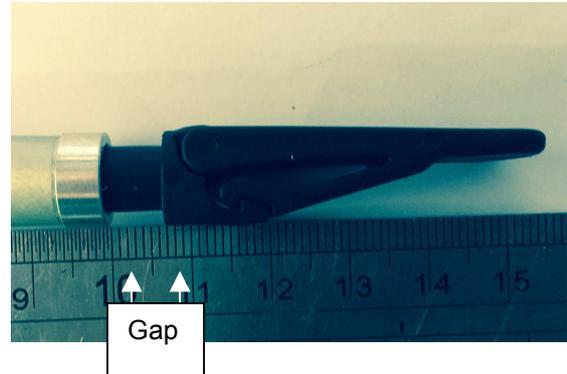
If you change fittings it is easiest to measure the gap between the existing fittings and the end of the batten. When the hinge fitting is replaced ensure the gap is the same. This will ensure tension is the same so wing tuning will not be required.

Replace all fittings with new fittings from Airborne.

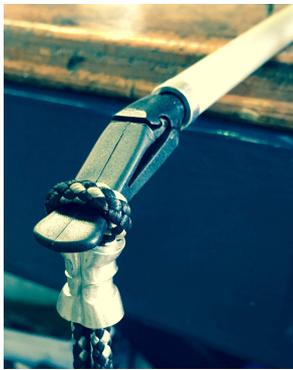
The latch fittings are batch tested prior to production to ensure conformity to the design requirements. To check your hinge batten fitting. The wing should be de-tensioned and the battens should be removed from the sail. Secure batten to a bench.

A load of 6.5 kg should be applied to the end of the batten as shown to ensure adequate latch security. A load cell or 6.5 litres of water can be used. A variety of sporting weights totalling 6.5kg is also an option.

Any fittings that fail during this test will require replacement.

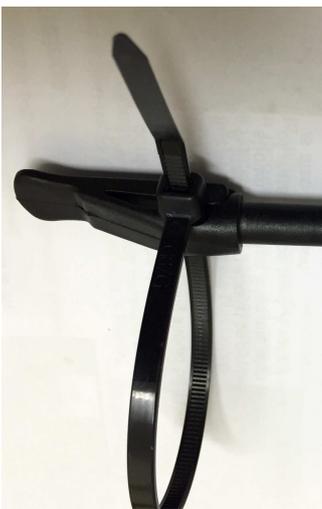
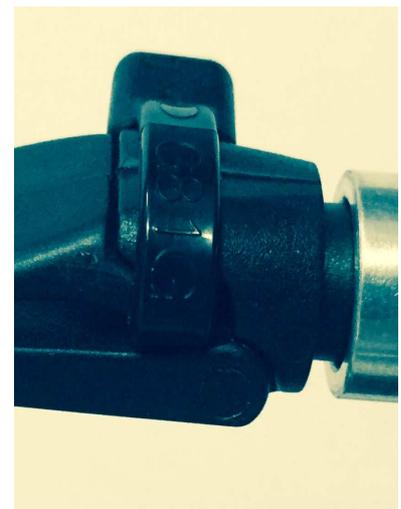
If you are unable to test your latches for security a cable tie can be tensioned around the latch when the latch is closed.

A commercially available cable tie with width of 4.8mm and thickness of 1.4mm is the best option for additional security.

Note the **position** and **orientation** of the cable tie.

This is quite a simple procedure and can be done without disassembling the wing.

Our testing has found that even an old fitting with obvious damage will hold the required test load.
